Lime Chemical Bridging, Sticking, and Flow Problems Solved

The Mahoning Valley Sanitary District in Mineral Ridge, Ohio, uses lime to soften its water. The lime is stored in four concrete bulk storage bins that were built in 1929–31 using 2- × 10-in. wood forms. Each bin stores 200,000 lb of lime, and the plant uses approximately 20,000 lb/d on average.

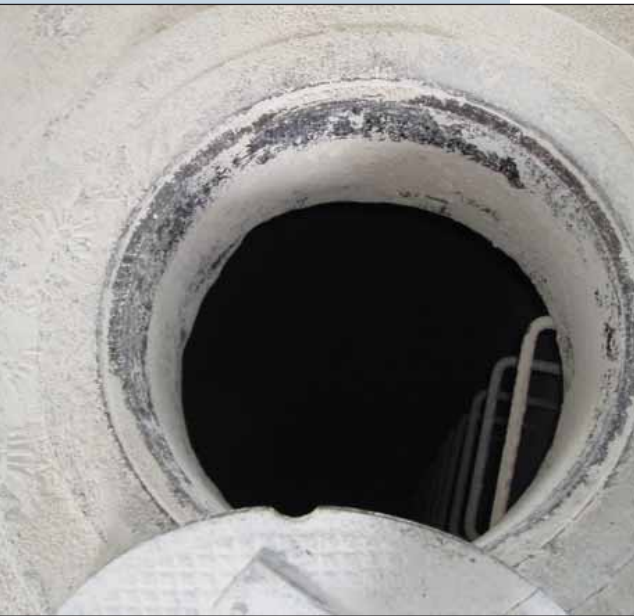
Simply taking the lid off of the lime bulk storage tank caused injuries to operators at a sanitary district in Mineral Ridge, Ohio.

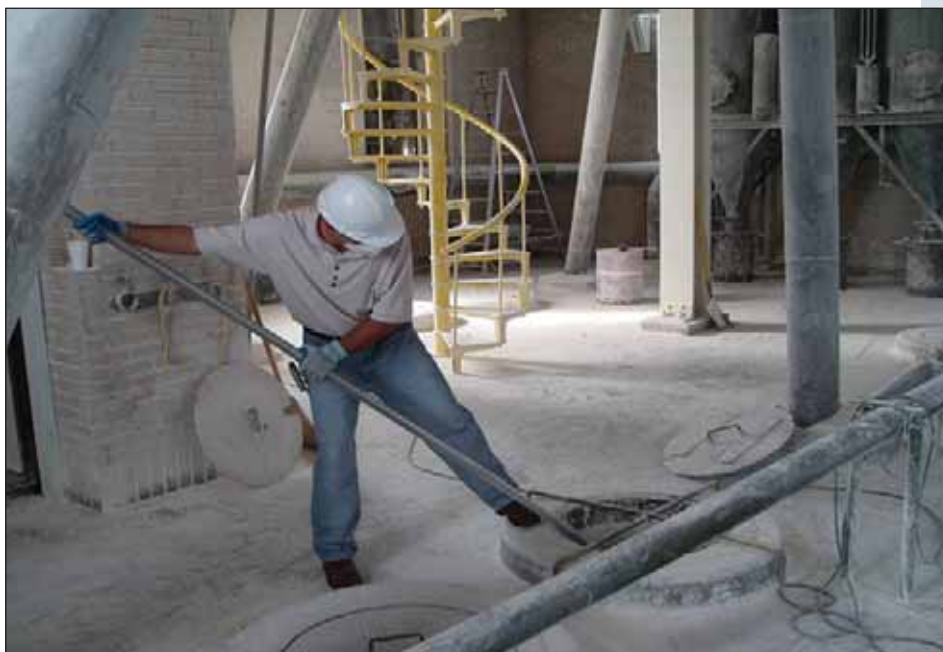
It's no surprise that operators experienced shoulder, back, and leg injuries while moving lime from bulk bins to hopper openings.

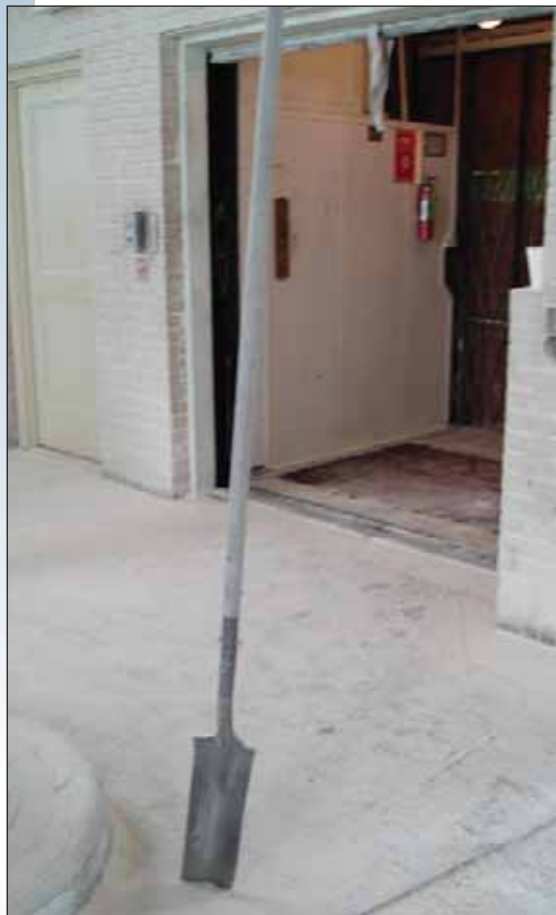
The 40-ft, 75-lb pole used to move the lime was difficult to use and contributed to personnel injuries and operations inefficiencies.
